## **FACTORS TO CONSIDER WHEN EVALUATING DAMAGE ON PIPELINES**

**Michael J. Rosenfeld, PE**

**Kiefner & Associates, Inc.**

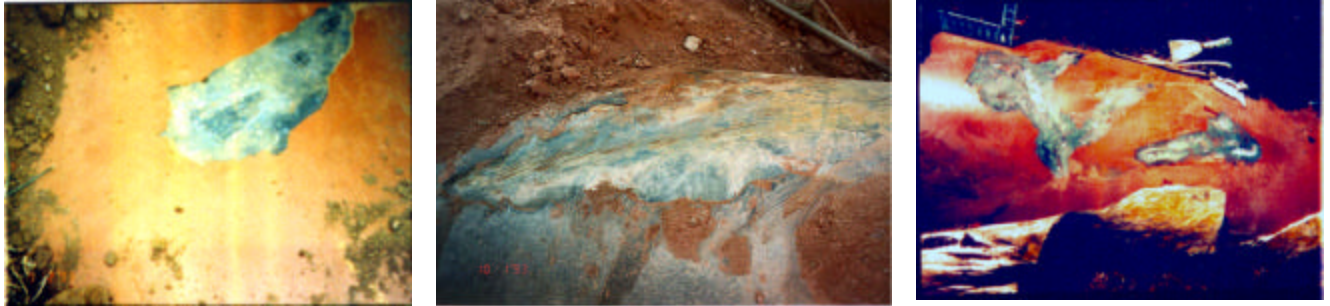
Examples of encroachment damage are shown in Figure 1. Common causes include contact from excavators, graders, ditchers, plows, directional drillers, and just about any other sort of equipment used to penetrate or move soil. General excavation is the most common source of damage, but everything from roadwork to farming has caused incidents, including the pipeline operator or his contractors hitting his own line. Offshore, encroachment damage arises from contact by ship keels and anchors.

**Figure 1. Examples of Mechanical Damage as Found in the Field**

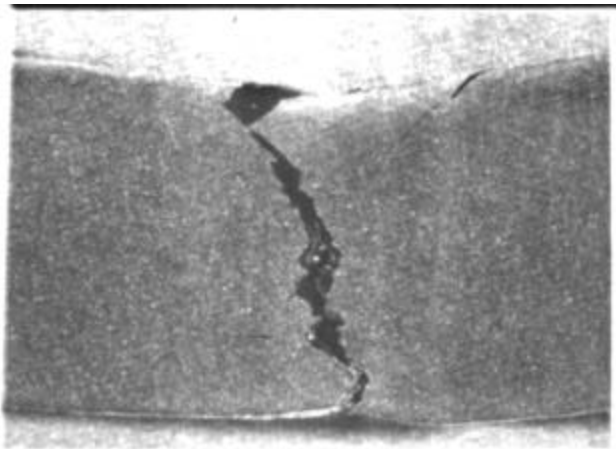
**(a)**

Metallurgical damage occurs where the striking object contacts and slides along the pipeline surface. Visually, the damage appears as a scrape or gouge, and might not look very severe. But within the scrape or gouge, plastic flow, metal transfer, and even remelting due to the heat of friction would have occurred at the contact point. For some depth below that, the microstructure is crushed and severely cold-worked, locally degrading the ductility and toughness. This type of damage is evident in a cross section at the root of a gouge. Figure 2(a) shows a cross section of a

fracture at a gouge. Figure 2(b) shows the severely crushed microstructure in the gouge just below the pipe surface, as well as cracks which often form due to “rerounding”.

**Figure 2. Cross Section of Cracking in Mechanical Damage**

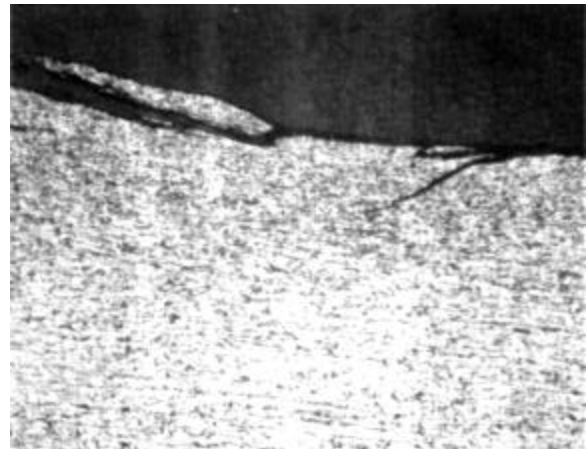
**(b)**

As the contacting object indents and scrapes along the pipe surface, the pressure in the pipe immediately pushes the dent back out (in other words, the dent “rerounds”) behind it. As the dent pushes out, very high tensile strains develop in the root of the scraped or gouged area which may cause cracks to form in the cold-worked, reduced-ductility metal. If the pipe doesn’t fail right away (which actually occurs in about 80% of encroachment damage failures), a crack is left which can grow in service. The crack may not be visible to the naked eye.

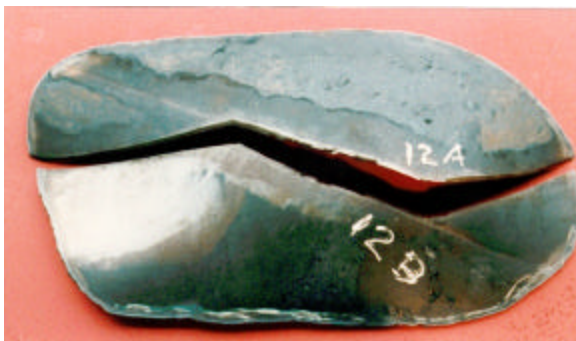
The interaction of metallurgical damage with rerounding behavior in the manner described above seems to explain the delayed nature of many mechanical damage failures. Encroachment damage failures typically occur in the crease left by the striking equipment, as in the example shown in Figure 3. Often multiple creases are present where such damage occurred, such as that shown from the inside of a pipe in Figure 4.

**Figure 3. Failure in a Gouge Crease**

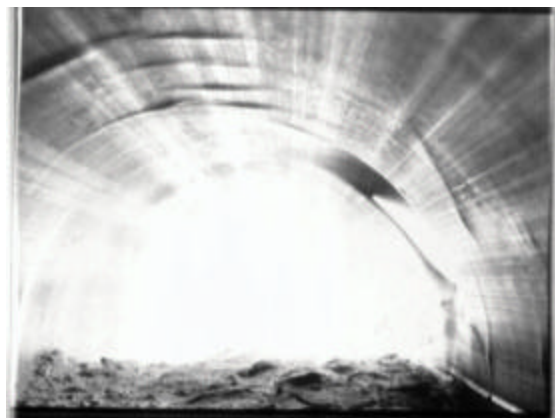
**Figure 4. Multiple Creases from Backhoe**

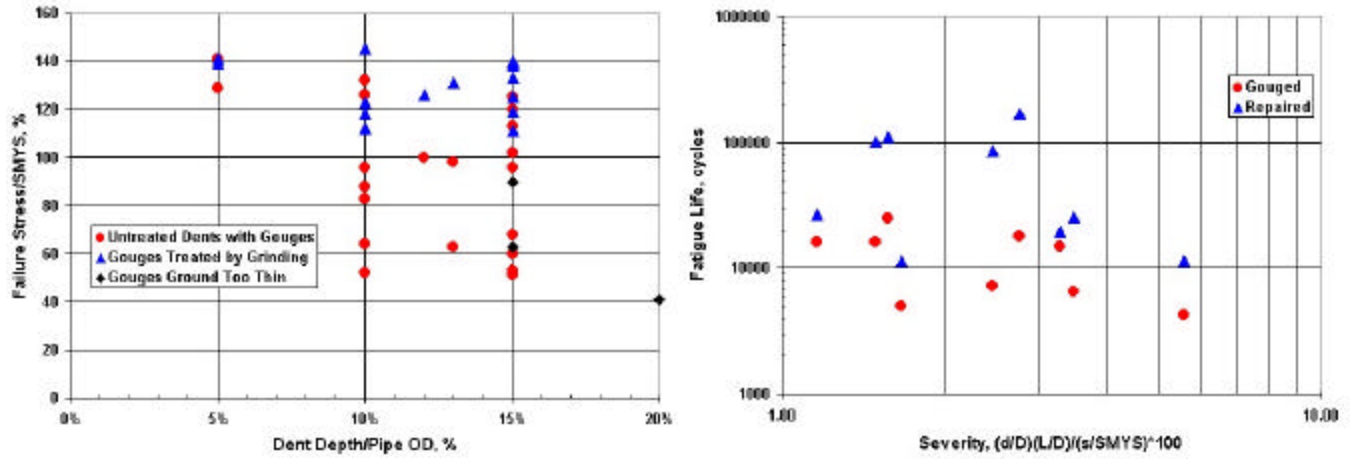
(a) (b)  
 Figure 5. Beneficial Effects of Grinding Damage on Burst Strength (a) and Fatigue Life (b)

Where the damage is light, it may be sufficient to simply grind the damage out and repair the coating. The safe length and depth of grinding may be determined from the following equation:

where  $L$  is the length of grinding,  $a$  is the depth of grinding,  $D$  is the pipe diameter, and  $t$  is the pipe wall thickness, in any consistent system of units. The maximum safe depth of grinding is 40% of the wall thickness. The pipe surface should be inspected to verify removal of any cracking, and to check the remaining wall thickness. The effectiveness of this repair technique was demonstrated by testing where

- the burst strength of pipe containing combined defects severe enough to cause failure at low stress was increased to well above 100% of SMYS by grinding them out, Figure 5(a), and

- the pressure-cycle fatigue life of pipe containing combined defects was increased by a factor of 2 to 10 by grinding them out, Figure 5(b).

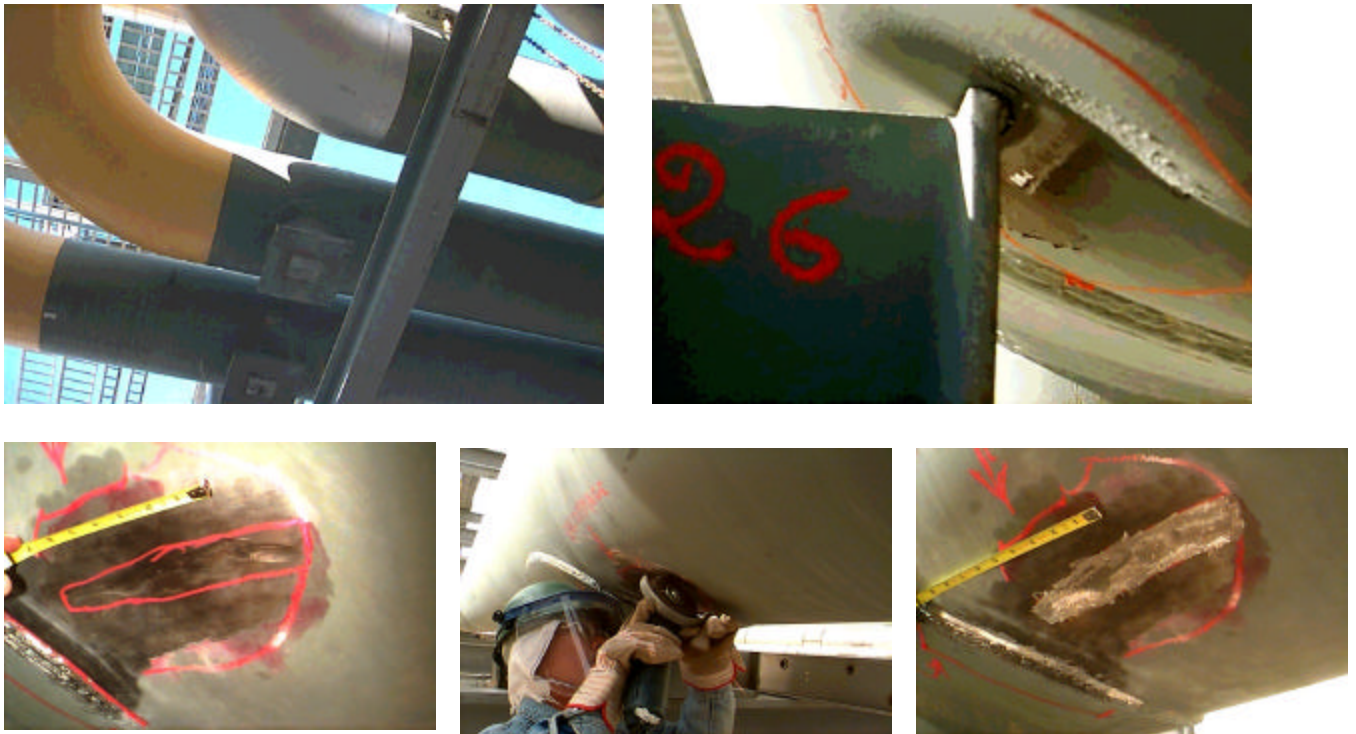
Figure 6 shows a pair of 36-inch OD gas flare lines that were damaged when they fell off their pipe rack during a plant upset. Also shown is the repair being made by careful grinding to a smooth contour, accompanied by surface NDE.

Figure 6. Mechanical Damage on Rack Piping and Repair by Grinding

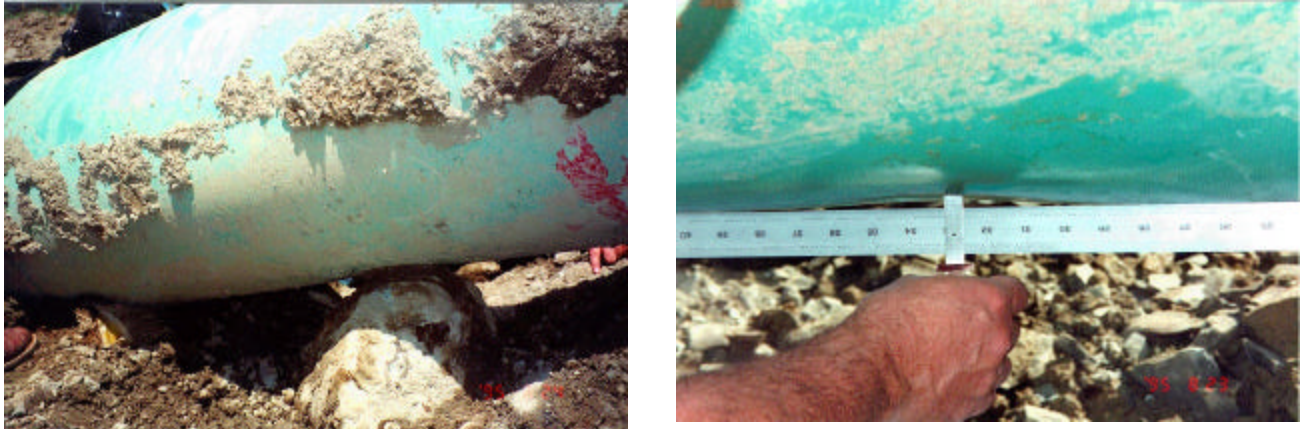
Examples of damage resulting from poor pipe installation practices are shown in Figure 9. In every case, the pipe was inadequately protected from settlement onto rocks in the ditch bottom. In general, urethane or styrofoam pillows are inadequate to support the pipe under the combined weights of the pipe, overburden, and hydrotest water or product inside the pipe.

**Figure 7. Typical Rock Indentation**

Rock shield wraps and thin-setting epoxy-based concrete coatings provide effective protection for the corrosion-prevention coatings in rocky soils, but cannot prevent indentation of the pipe due to settlement. Heavy concrete coating (1 inch or thicker) provides more effective protection from rock, though it can be penetrated by sharp rocks. Graded fill materials (sand, for example) can provide adequate padding when properly installed. Setting pipe on regularly spaced sandbags in the ditch and pouring the padding over the pipe will leave an unfilled gap below the pipe, resulting in spanning over the supports and settlement of the pipe into the gap. The most effective way to prevent damage in the ditch is to diligently remove rocks from the ditch bottom or else pour in a generous bed of padding sand or fines before laying the pipe in.

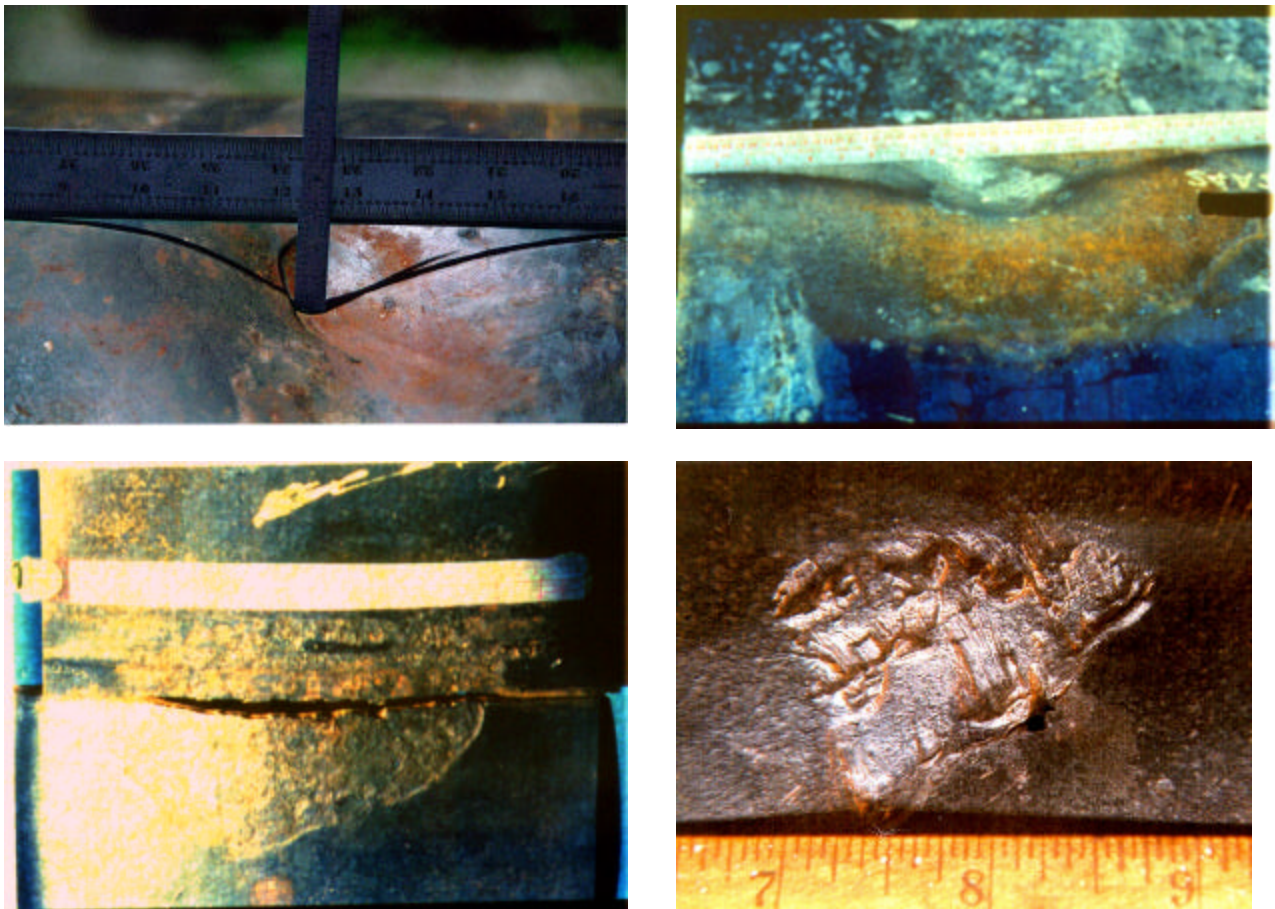
Examples of these problems are shown in Figure 8. Failures caused by rock punctures occur as leaks; failures caused by corrosion or environmental cracking that develops as a result of rock damage may occur as ruptures. Rocks have been documented in at least 5% of reportable incidents caused by corrosion. The actual contribution of rocks to corrosion problems is likely to be higher than that.

**Figure 8. Forms of Damage from Rocks: Puncture, Coating Damage and Corrosion, Local Mechanical Damage, and SCC (clockwise from upper left)**

- welded steel sleeves, either designed for internal pressure, or with the ends left unwelded (a hardenable filler in the dent space is recommended in either case)
- composite wrap repair with hardenable filler in the dent space
- repair to the coating only (appropriate for gas pipelines).

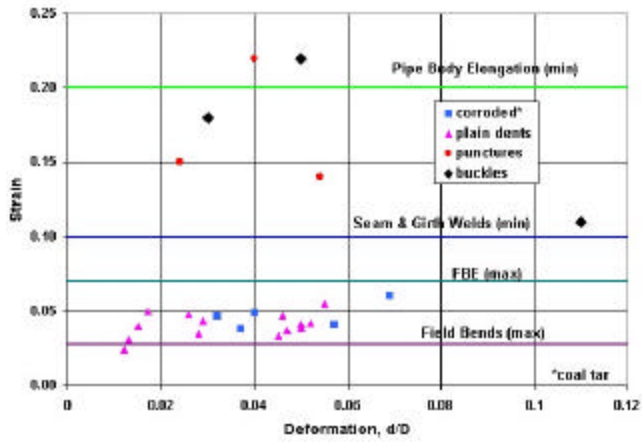
An alternative to dent depth that is gaining some usage is to make use of the actual dent geometry (as measured in the field or by high-resolution deformation ILI tools) to estimate the strains associated with the dent, since strain is a measure of material damage. As Figure 9 shows, dent depth does not correlate to strain, but thresholds for some kinds of failure do correlate to strain. The question is, how much strain is too much? We know that strain up to 3% is acceptable because that is what is incurred in allowable cold field bends. Evidence is given by the corroded dents that coal tar may disbond at strains of 4% to 5%. Test specifications for fusion-bonded epoxy require surviving strains between 2% and 3%, though test straps have been observed showing crack resistance to strains of 7%. Finally, cracks have been observed in pipeline buckles at strains that are a large fraction of the uniaxial elongation. Hence a maximum strain of 6% would provide a reasonable factor of safety against metal failure in a restrained dent, with the onus that continued monitoring for corrosion may be necessary in the long-term, depending on coating type. The ASME B31.8 Code is adopting new allowances for strains in deformations up to 6% as an optional alternative to depth-based limits.

Figure 9. Strain Levels Associated with Damage Thresholds

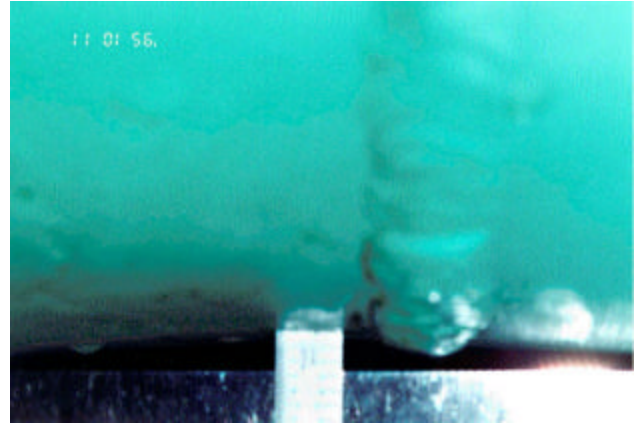
Occasionally, rock dents are discovered on pipeline girth or seam welds, such as what is shown in Figure 10. Present ASME Code requirements are that such a dent must be repaired. However, tests and analysis demonstrate that if a weld is ductile and free of gross defects, and the operating pressures are not severely cyclical, the weld can tolerate a dent. The ASME B31.8 Code is adopting new allowances to permit shallow dents in welds of sound quality.

Figure 10. Rock Dent on a Girth Weld
